[Scenario]

DGS-6600-2 will filter BGP route 192.168.1.0/24 that sent from DGS-6600-1

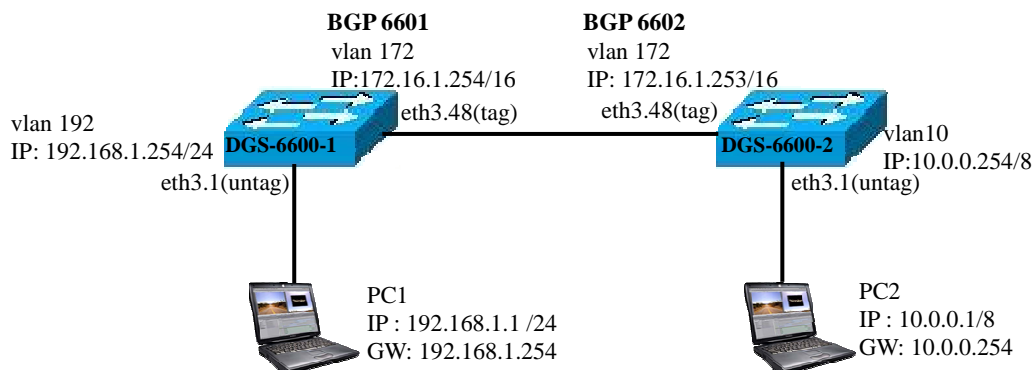
[Topology]

```
route-map BBB permit 10
  set community 20850:35030
!
vlan 172
!
vlan 192
!
interface eth3.1
  access vlan 192
!
interface eth3.48
  trunk allowed-vlan 172
!
interface vlan172
  ip address 172.16.1.254/16
!
interface vlan192
  ip address 192.168.1.254/24
!
router bgp 6601
  network 172.16.0.0
  network 192.168.1.0 route-map BBB
  redistribute connected
  neighbor 172.16.1.253 remote-as 6602
  neighbor 172.16.1.253 send-community
```

```
route-map UAIX-IN deny 10
  match community DTEL
!
vlan 10
!
vlan 172
!
interface eth3.1
  access vlan 10
!
interface eth3.48
  trunk allowed-vlan 172
!
interface vlan10
  ip address 10.0.0.254/8
!
interface vlan172
  ip address 172.16.1.253/16
!
router bgp 6602
  network 10.0.0.0
  network 172.16.0.0
  redistribute connected
  neighbor 172.16.1.254 remote-as 6601
  neighbor 172.16.1.254 route-map UAIX-IN in
!
ip community-list DTEL permit 20850:35030
```
