**Firmware Version:** V1.81.004  
**Prom Code Version:** V1.00.016  
**Published:** 2023/08/30

These release notes include important information about D-Link DGS-1510 Series firmware revisions. Please verify that these release notes are correct for your switch:

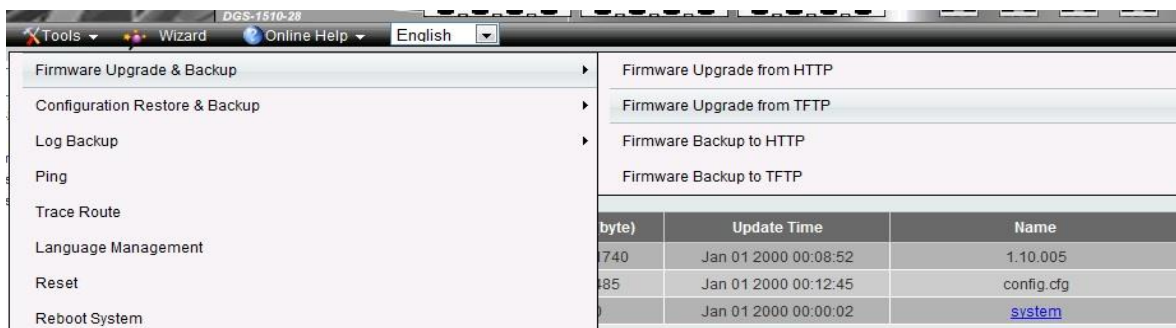
- To update switch's firmware or configuration file via TFTP, select **Tools > Firmware Upgrade & Backup > Firmware Upgrade from TFTP**.

- Enter the TFTP Server IP address.
- Enter the name of the firmware file located on the TFTP server.
- Enter the destination path and the desired file name.
- Click "**Upgrade**" button.

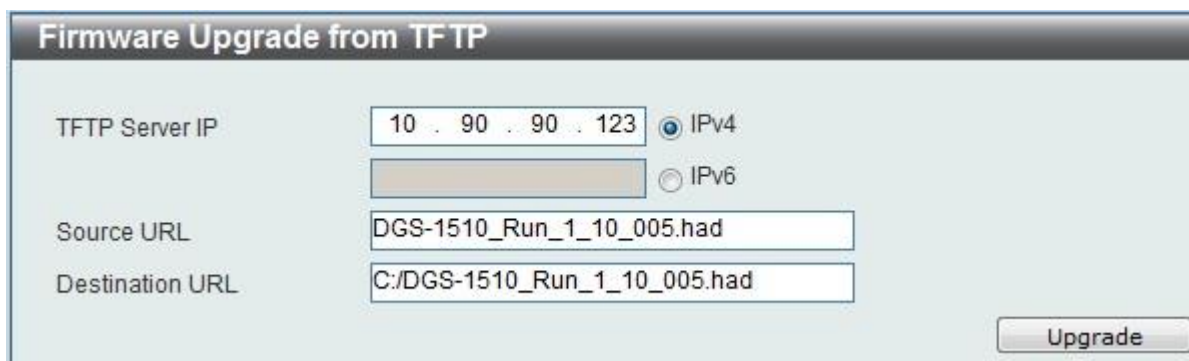
- Transmission will start and wait until the status is completed by displaying **100%** complete.
- Alternatively, the switch's firmware or configuration file can also be upgraded via HTTP, select **Tools > Firmware Upgrade & Backup > Firmware Upgrade from HTTP**.

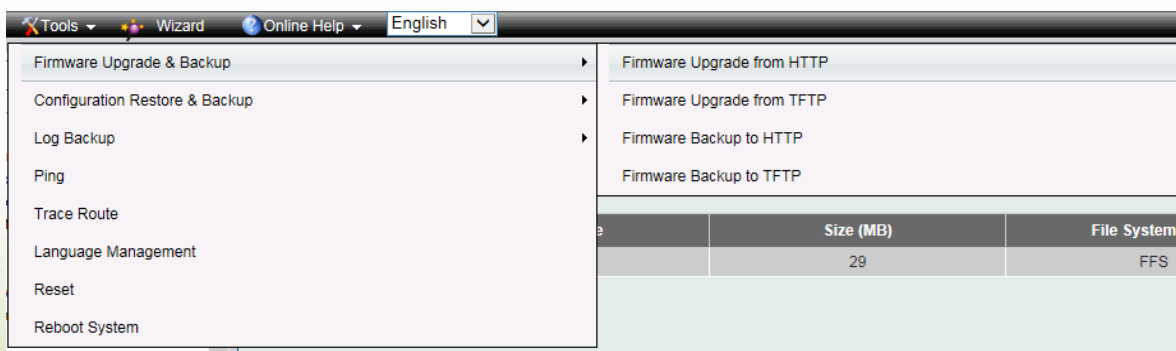
- Enter the source and destination file.
- Click "**Upgrade**" button.

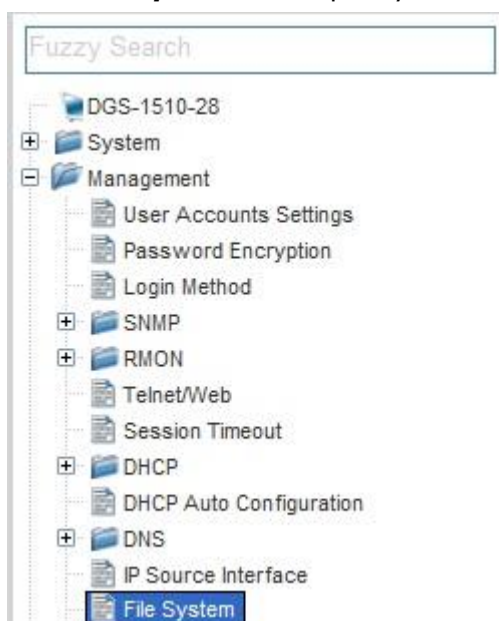
13. Transmission will start and wait until the status is completed by displaying **100%** complete.
14. To select the boot up image used for next reboot, click **Management > Flash System** in the function tree and then click the **C:** drive name. When you see the files list, click corresponding **Boot Up** button to specify the firmware that will be used for next and subsequent boot up.

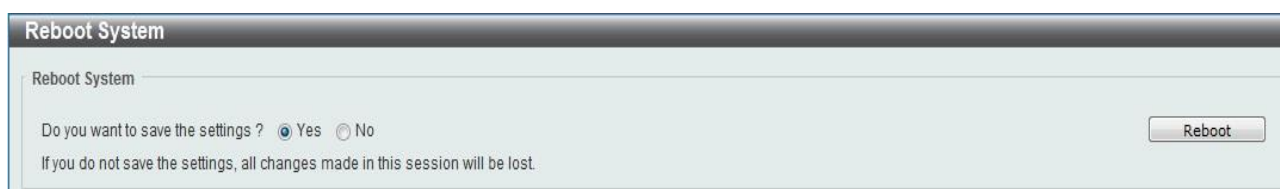
16. Select **Yes** and click **Reboot** button to reboot the switch.
